# **EXHIBIT F**

# Degradation of polypropylene in the human eye: A sem-study

W.L. JONGEBLOED<sup>1</sup> and J.F.G. WORST<sup>2</sup>

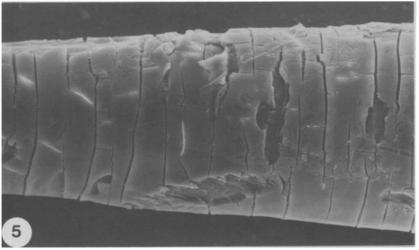
Figures 2 and 3 represent parts of the left side of the suture, cracks perpendicular to the longitudinal axis of the suture are visible. Lumps of the surface layer are nearly detached or are already missing (arrows). Note also the irregularity of the diameter of the suture in both pictures.

Figure 2. Part of left side of suture of Figure 1, showing cracks in surface layer and missing part of surface layer (arrows); note irregular diameter. Magn.  $225 \times$ .

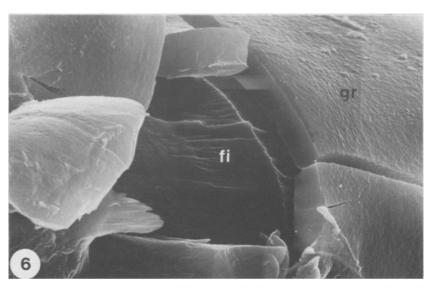
Figure 3. Part of left side of suture of Figure 1, showing cracks in surface layer and nearly detached lump of surface layer (arrow); note somewhat twisted shape of suture. Magn.  $325 \times$ .

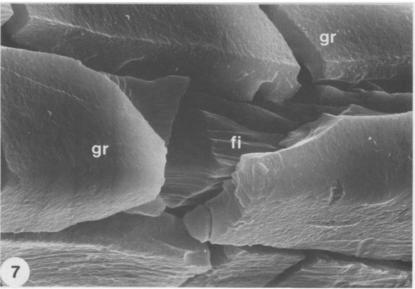
Figure 4 and 5 also represent parts of the left side of the used suture of Figure 1. The cracking of the surface layer is very obvious in Figure 4; almost the complete surface layer has been split off from the underlying layer. The outer surface of the lumps is covered with a thin layer of probably organic material with a slightly granular appearance (Figure 4). Closer to the central part of the suture (the part which was not in direct contact with the tissue) the disintegration of the polypropylene appears to be considerably less extensive. Figure 5 represents a part of the suture left of the centre, the cracks in the surface layer are already present and the diameter decreases towards the left side of the suture.

Figure 4. Part of left side of suture of Figure 1 showing completely disintegrated surface layer, large lumps nearly detached. Magn.  $1000 \times$ .

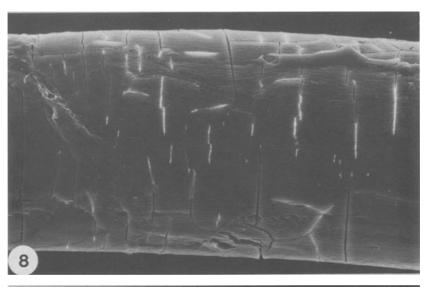
Figure 5. Part of left side of suture of Figure 1, close to central part of suture. Surface less attacked; note decreasing diameter towards left side. Magn.  $300 \times$ .

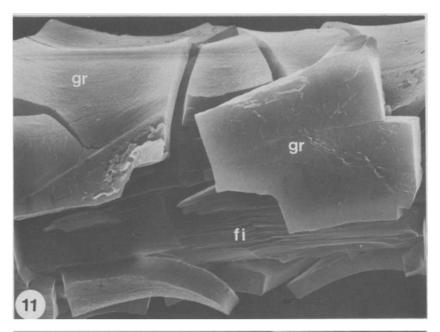
Figure 11 shows the destruction of the polypropylene in a rather dramatic way; the complete surface layer has broken into pieces, exposing the subsurface layer. The outside layer is covered with some deposits, mainly of a granular nature.

Figure 11. Part of right side of suture of Figure 1 showing almost complete degradation of surface layer, large lumps have detached exposing subsurface layer with fibrillar character (fi). Note granular deposit on lumps (gr). Magn.  $975 \times$ .

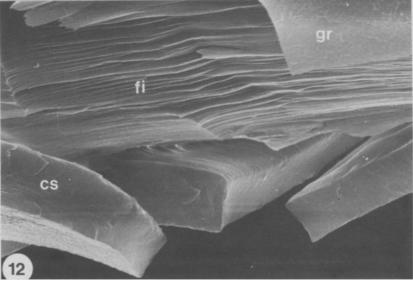
The subsurface layer is observable in more detail in Figure 12 (detail of Figure 11); the fibrillar character of this layer is clearly visible, while the splitting of the surface layer is noticeable, particularly at the cross-sections of the split-off lumps in the lower part of the picture.

Figure 12. Detail of Figure 11 showing subsurface layer (fi) and split-off lumps of surface layer in more detail (cs). Magn.  $2500 \times$ .
